Manhole Inspection Summary

Manhole # S37E__021MH

Insp Date: **8/25/08 2:27 PM**

Location Address: **across from 101 n gay st**

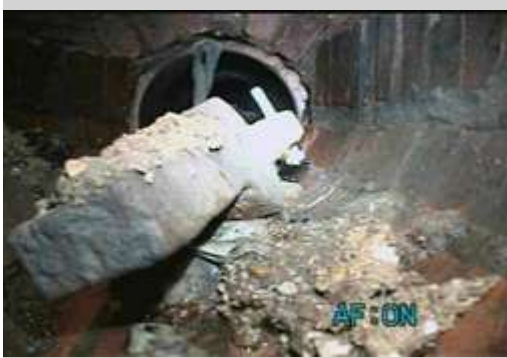
Defect 2

Condition: ☐ Sound ☐ Cracked ☐ Root Intrusion ☐ Deteriorated ☐ Leaks ☒ **Debris**

channel debris

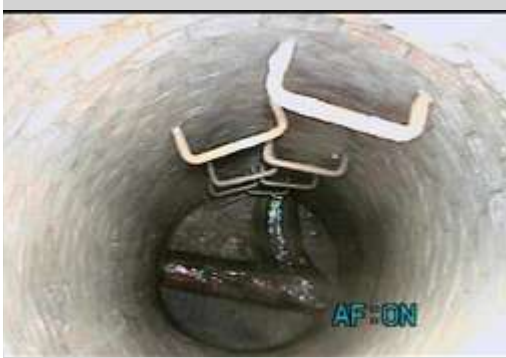
Defect 1

Count: **8** Missing: **0** ☒ **Corroded**

steps

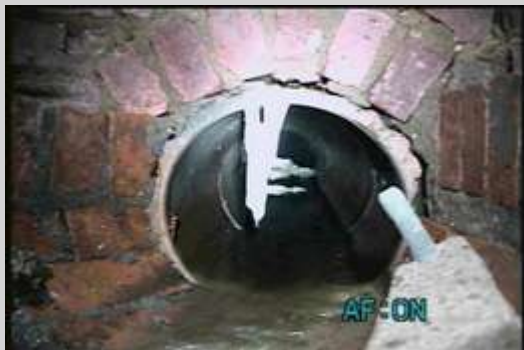
12 O'Clock Outflow

10 in. Circular Gravity Sewer
Pipe Out @ 12 O'Clock

Pipe Material: **Clay** ☐ Pipe Lined

Invert Depth: **14.50** (ft.) Flow Characteristics: **Fast**

Infiltration: **None** Pipe Seal Cond: **Unknown**

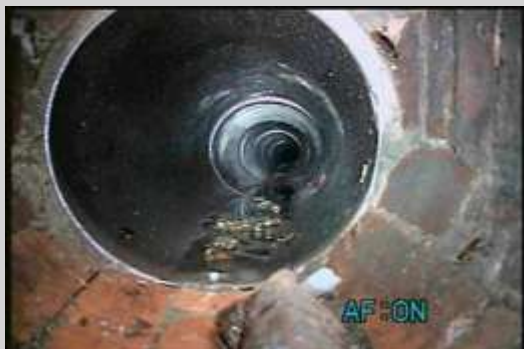
6 O'Clock Inflow

10 in. Circular Gravity Sewer
Pipe In @ 6 O'Clock

Pipe Material: **Clay** ☐ Pipe Lined

Invert Depth: **14.25** (ft.) Flow Characteristics: **Slow**

Infiltration: **None** Pipe Seal Cond: **Unknown**

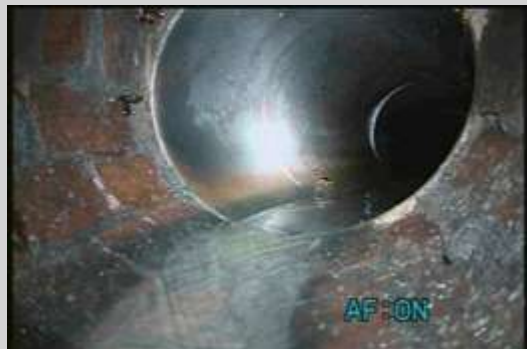
9 O'Clock Inflow

10 in. Circular Gravity Sewer
Pipe In @ 9 O'Clock

Pipe Material: **Clay** ☐ Pipe Lined

Invert Depth: **14.16** (ft.) Flow Characteristics: **Fast**

Infiltration: **None** Pipe Seal Cond: **Unknown**
